Manhole Inspection Summary

Manhole # S09II1013MH

Insp Date: **1/12/09 2:27 PM**

Location Address: **3518 VIRGINIA AVE**

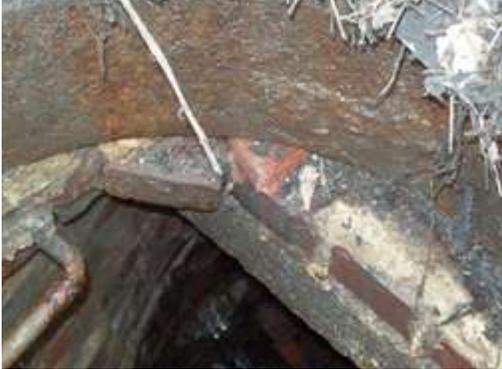
Defect 1

Condition: Sound Cracked Root Intrusion **Loose Brick** **Deteriorated**

LOOSE BRICKS AND DETERIORATED CHIMNEY

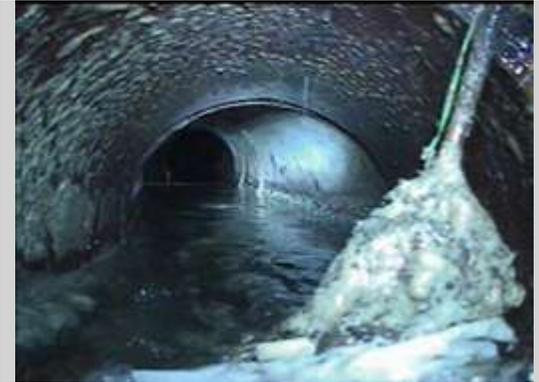
12 O'Clock Outflow

12 in. Circular Gravity Sewer
Pipe Out @ 12 O'Clock

Pipe Height: **12** (in.) Rod and Bar (Angled)
Pipe Material: **Clay** Pipe Lined
Invert Depth: **8.33** (ft.) Flow Characteristics: **Fast**
Deposits: None Mud Sludge Debris Grease
Silt Depth: (in.) Deposits Extent:
Infiltration: **None** Pipe Seal Cond: **Sound**

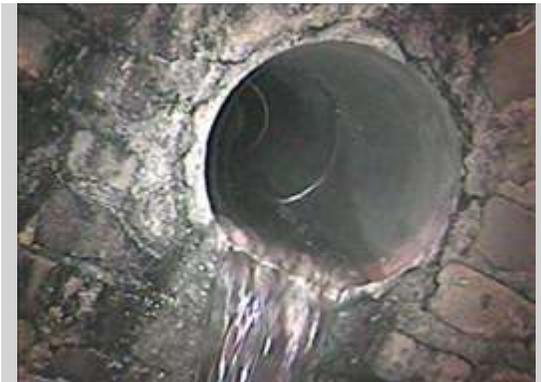
3 O'Clock Inflow

LOOSE BRICKS AND DETERIORATED CHIMNEY

Pipe Height: **8.4** (in.) Rod and Bar (Angled)
Pipe Material: **Clay** Pipe Lined
Invert Depth: **6.24** (ft.) Flow Characteristics: **Fast**
Deposits: None Mud Sludge Debris Grease
Silt Depth: (in.) Deposits Extent:
Infiltration: **None** Pipe Seal Cond: **Cracked**

Drop: **Inside** **Direct**
Angled: Reading: (ft.)
Inv Depth: **8.24** (ft.)
Drop Condition: **Clogged**

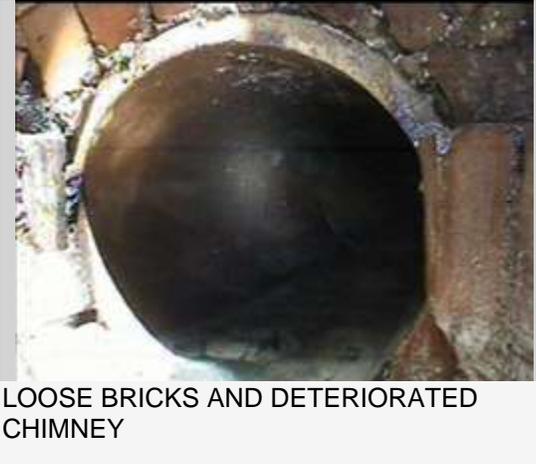
9 O'Clock Inflow

LOOSE BRICKS AND DETERIORATED CHIMNEY
